# **Design Guidelines**

Town of Morristown, New Jersey

A Handbook for the Preservation and Improvement of Morristown's Historic Properties

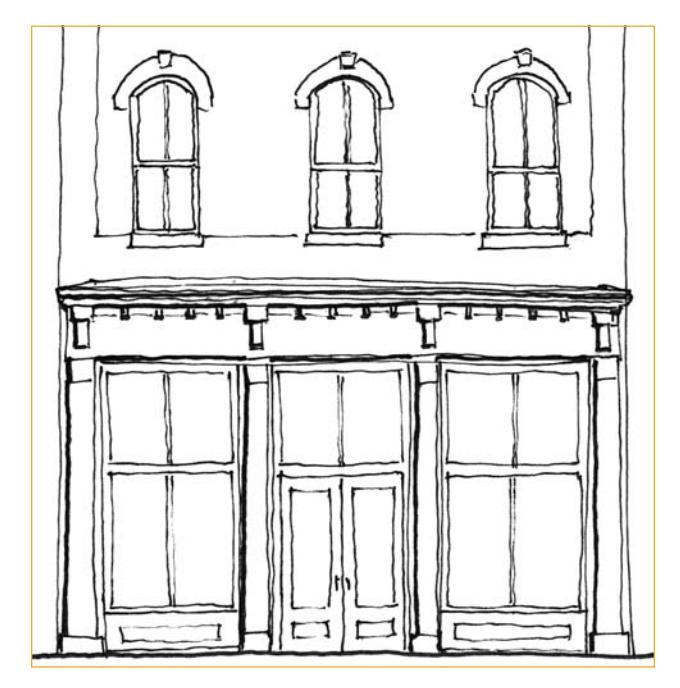
Threaded through the entire composition is the structure that establishes the storefront's articulation while carrying the weight of the upper facade. In the earliest storefront systems, this structure was composed of either stone or wood. With stone construction, the storefronts reflected the post-and-beam system that had persisted for centuries, where the size of the storefront window (or door) bay reflected the limited span of the stone lintel above. With nineteenth-century wood construction, a timber could efficiently span about twenty-two feet. This dimension, with a masonry-bearing wall on either side, is reflected in the typical commercial lot sizes throughout downtown districts.

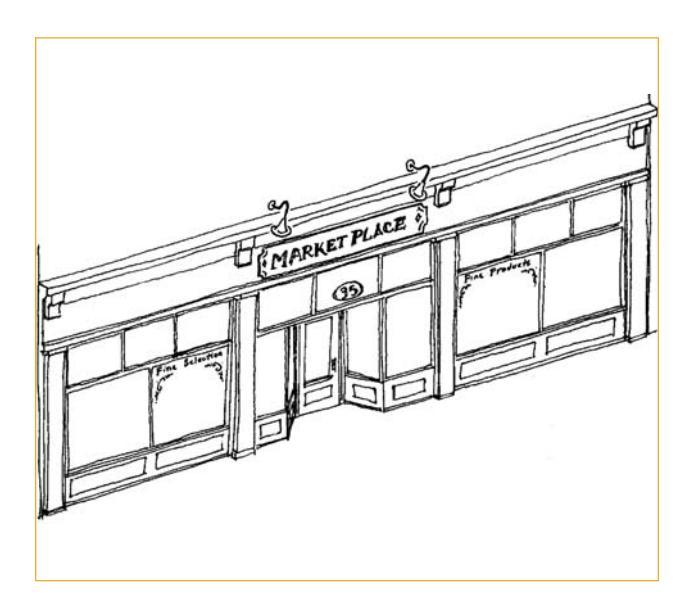
The availability of cast iron elements had a major impact on storefront design. The use of slender cast-iron columns allowed larger display windows, while cast-iron beams replaced the earlier stone and wood spans. Cast iron also offered tremendous decorative opportunities, since the molten metal could be poured into forms that were detailed for architectural expression as well as structural functionality. In larger cities, it was not uncommon for the entire facade of mid-to-late 19th century commercial buildings to be executed in cast iron. Because cast iron had to be painted, its decorative nature promoted the use of intricate paint schemes in bold Victorian colors.

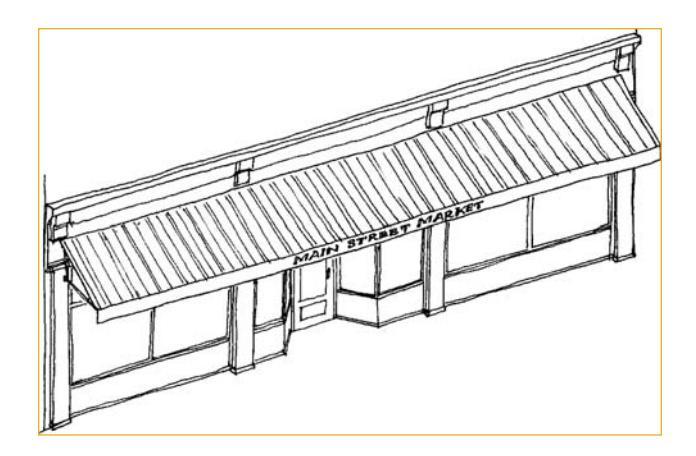
Awnings should be canvas material over retractable metal frames. Fixed plastic or metal awnings are historically inappropriate and visually intrusive. The size and design of the awning should be such that it does not dominate the façade, but rather complements it. Care should be taken during the installation of awnings not to damage the historic fabric. They should be removable without disturbing the elements of the façade. Awnings should be placed in such a manner that they do not obscure the historic cornice and entablature of the storefront. The design of the awnings should not allow water accumulation that can in turn affect the building. An awning can often also serve as a location for primary signage, as well as providing shade and solar control. The signage on the awnings, though, should be controlled and limited to simple painted letters on the valence. Colors of awnings and the signs on them should also be compatible with the colors of the building façade.

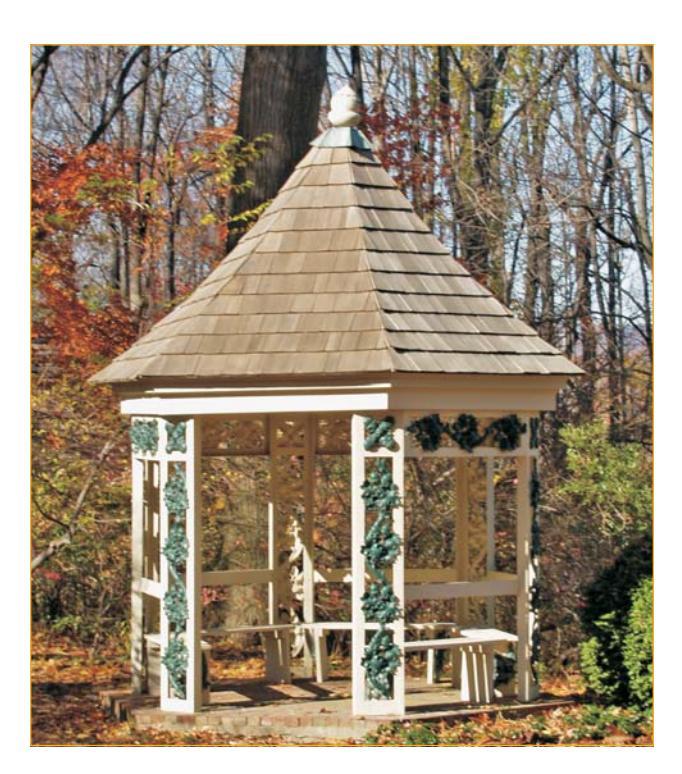
Typical elements of site design found in residential neighborhoods include fencing (wrought, cast iron or wood); benches; decorative paving; and garden elements such as bird feeders, pavilions, historic horse mounts, fish ponds, water fountains, and sometimes artistic sculptures. While most urban commercial buildings typically stand shoulder to shoulder or with only narrow alleys between, some of these historic site elements may be encountered there as well. These elements should be repaired and maintained, since they connect the building to its surroundings. New site elements should be compatible in materials and style.

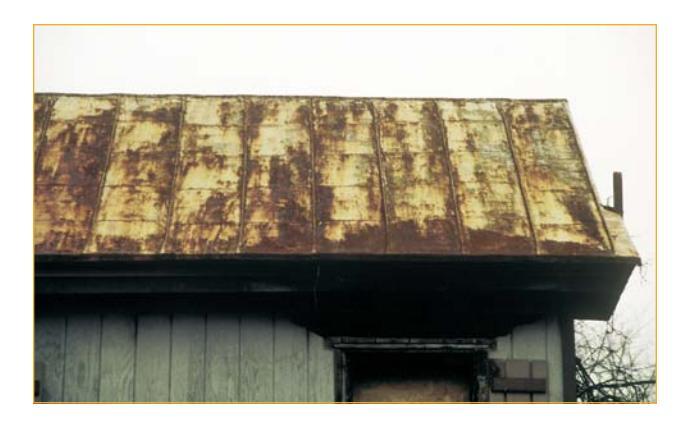
Check for cracks, warps, distortions, or weak areas, loose or damaged seams, loose attachments. Check for loose, damaged or missing sections. Check substrate underneath for moisture damage, especially at attachment points. Replace damaged or missing sections to match existing sections. Repair leaks and weak areas. Reattach to repaired masonry or wood substrate. Paint colors for flashing should match adjacent construction.

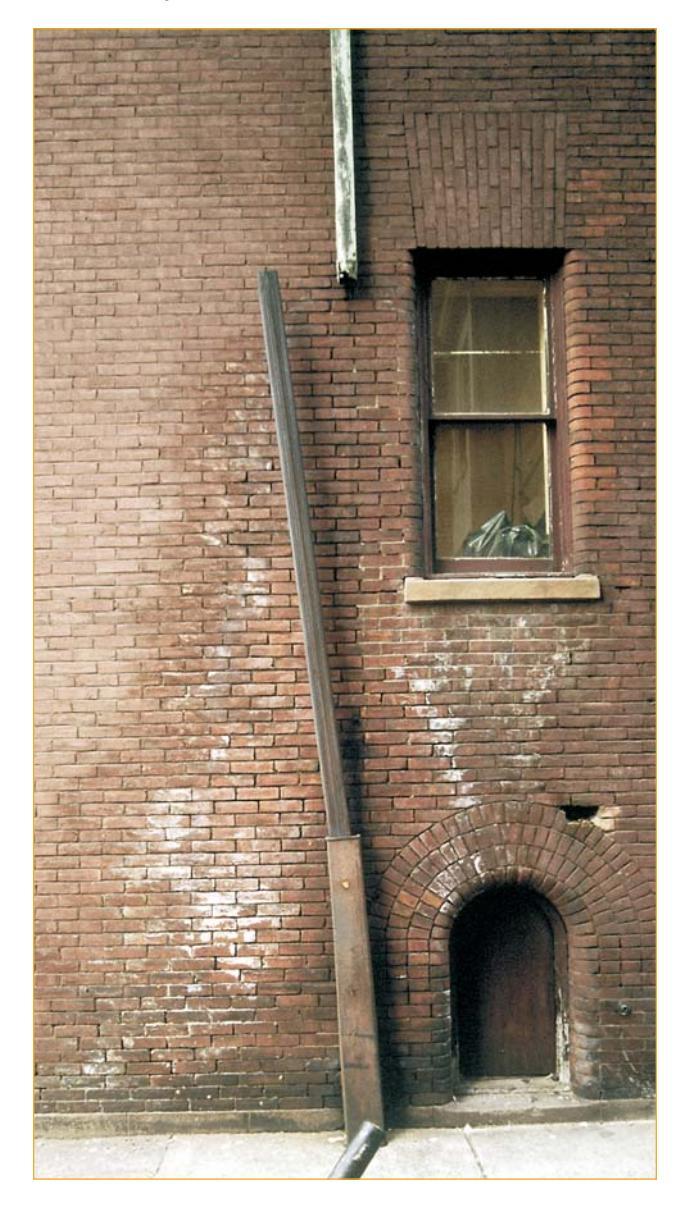
Look for leaks or blocked sections of gutters and downspouts during a heavy rainstorm. Clean system of any blockages and repair leaks. Check for any loose gutters and downspouts. Reattach as necessary.

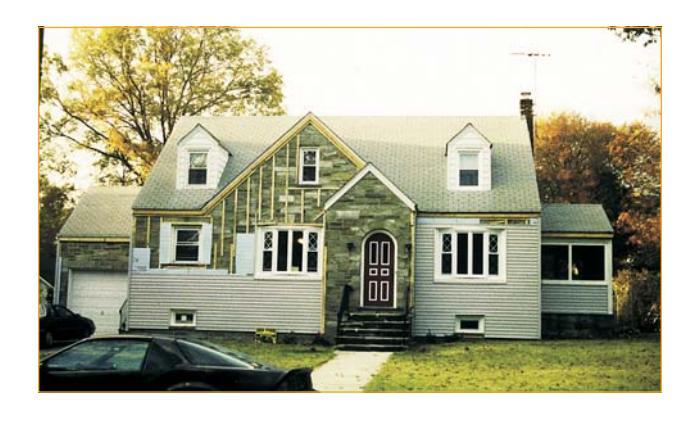
□ Check for loose units of masonry and missing or deteriorated mortar. Repoint joints that have loose or crumbling mortar, using mortar that matches original in color, texture, constituent composition, and workmanship. Mortar should not have high Portland cement content and should be no harder than surrounding brick or masonry or original mortar. Conduct the following procedure: remove deteriorated or loose mortar with hand tools to a minimum depth of 2.5 times joint width; clean joints; apply fresh mortar to wetted joints in layers not thicker than one quarter inch. Joints should be slightly recessed to maintain original width and tooled to match original finish.

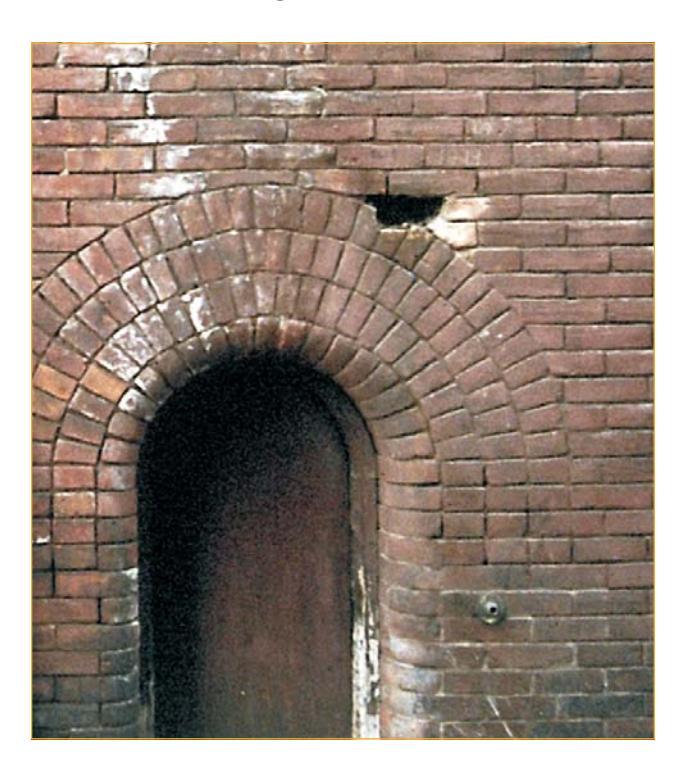
□ If the masonry is heavily soiled, clean only with materials and techniques that will not damage the masonry. Scrubbing with natural bristle brush wetted with natural detergent in water is usually sufficient to remove dirt and grime. Sandblasting, wire brushes, grinders, sanding discs, or other abrasive methods should not be used, nor should any harsh chemical that weakens the masonry be applied. Any chemical cleaner, if required, should be chemically neutralized and thoroughly rinsed off in order to remove residues that could damage masonry or finishes. Pressure water washing, if
